Inspection Report
Minerals Regulatory Program
Report Date: September 13, 2006

Mine Name: Bromide Basin
Operator Name: Unico

Permit number: M0170031
Inspection Date: August 28, 2006
Time: About 4:30-6:30 PM

M0170031, Bromide Basin Mine, Unico

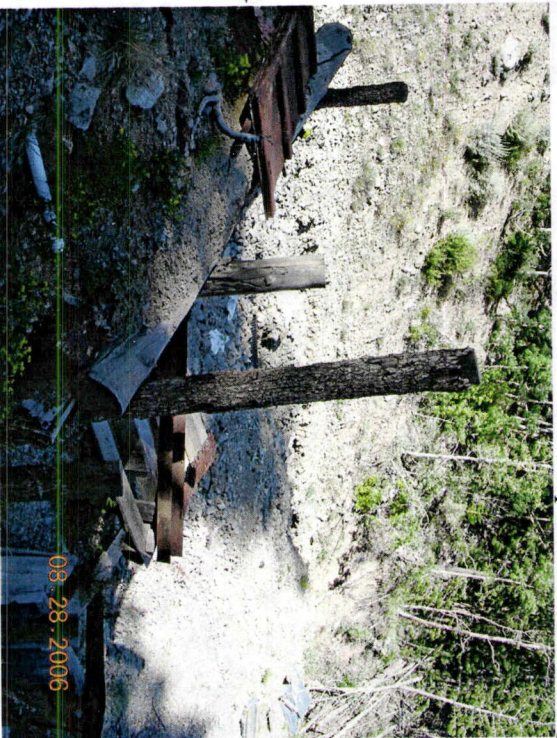
There are two portals which I understand are called the Bromide Mine and the Middle Mine. We parked where the road from Copper Ridge crosses the drainage then hiked up to the mines. At the place where we parked, there is a retaining wall (Photo 1), and there were some facilities below the retaining wall that were damaged or destroyed by heavy snow, slides, and runoff during the winter/spring of 2004-2005 (Photo 2).

Photo 1. Log retaining wall.

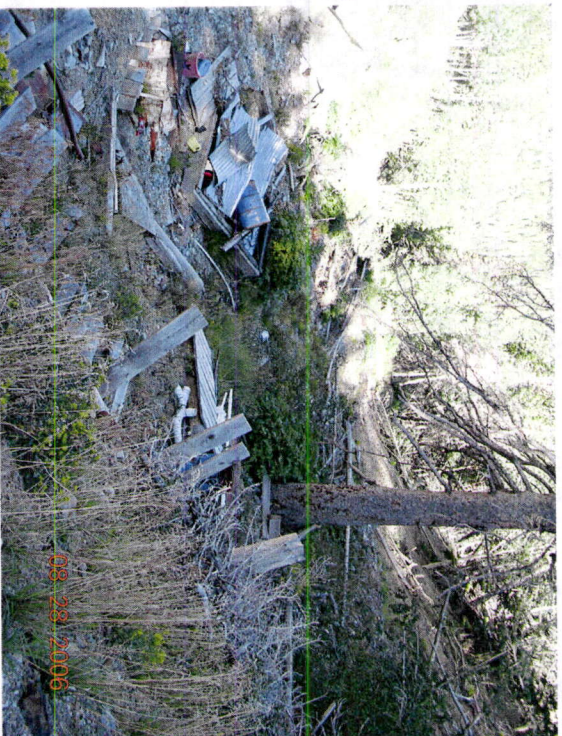
Photo 2. Some of the damage apparently caused by slides or runoff in 2004-2005.

The process of cleaning up damage from the slides will probably take a while, but the operator needs to begin taking care of this problem.

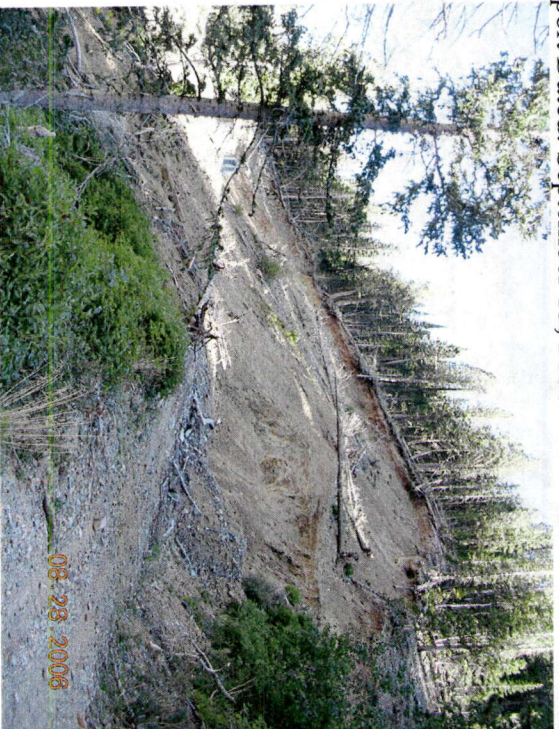
A portion of the access road is shown in Photo 3. I could not tell if the operator has recently tried to widen this road or if the side cut is unstable and eroded or was subject to mass failure during the winter of 2004-2005.

Photo 3. It appears this cut has suffered some degree of mass failure or that the operator was trying to expand the road.

In some places the road runs parallel to the stream channel, and the operator should see whether it would be feasible to have the entire road to the side of the stream. The road has apparently been in the same location for many years.

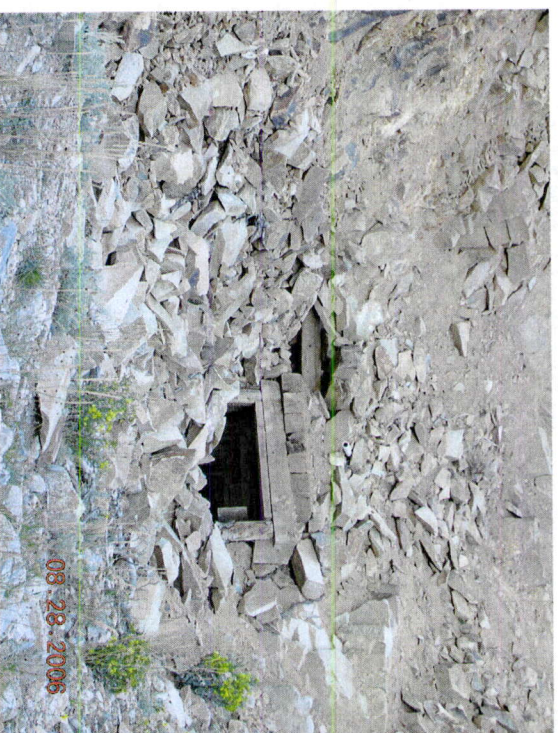
The Middle Mine (Photo 4) is about one-fourth mile up from the retaining wall. As can be seen in Photo 4, the portal was open, but several rocks had fallen in front of it. At this site, there is a cabin with bunks, food, etc., and there was also a building that had collapsed (Photo 5).

Photo 4. The Middle Mine portal.

The portals need to be secured to restrict entry by the public. This is required by rule R647-3-107.1.11 which says "The operator shall minimize hazards to the public safety and welfare during operations. Methods to minimize hazards shall include but not be limited to the closing or guarding of shafts and tunnels to prevent unauthorized or accidental entry in accordance with MSHA regulations." **I will issue a notice of violation if this problem is not corrected by the next inspection.**

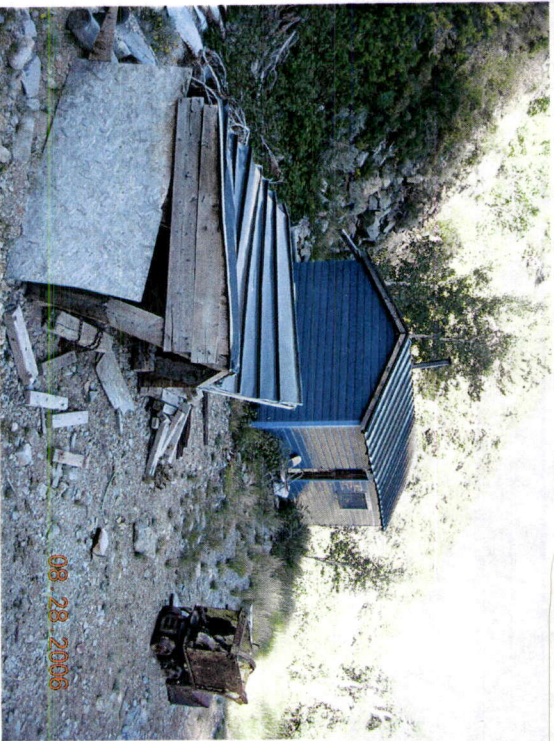
Photo 5. Buildings near the Middle Mine portal.

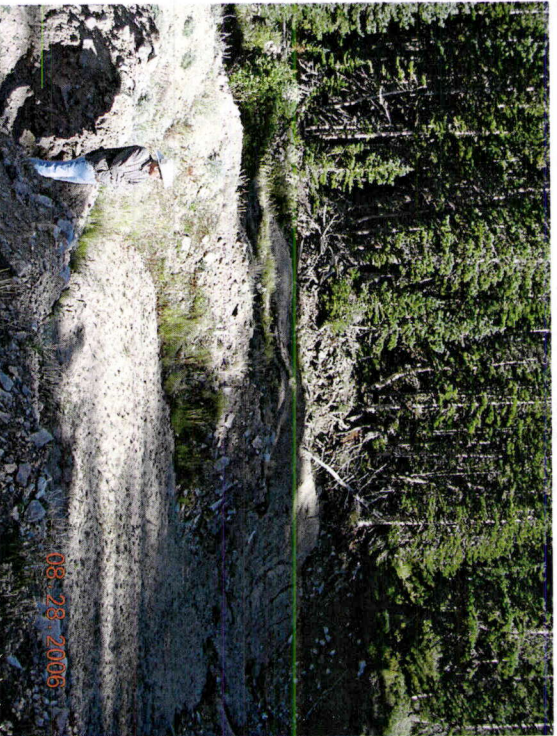
Photo 6. Pond just below the Bromide Mine.

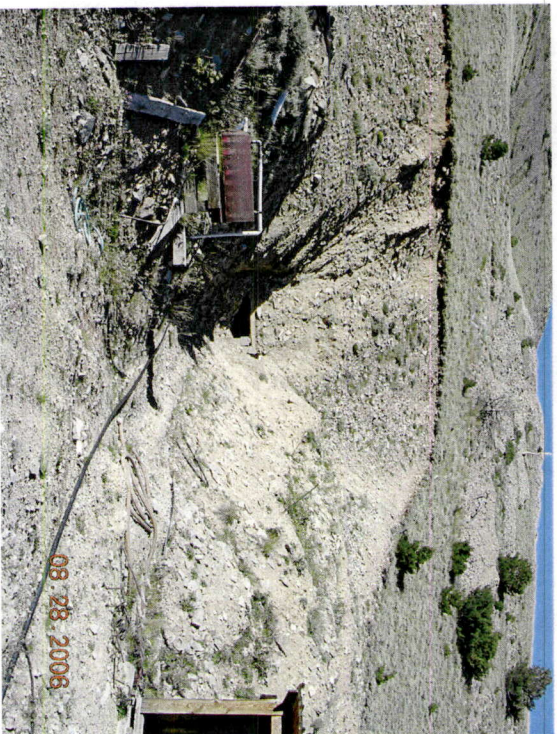
The Bromide Mine (Photo 7) is about one-fourth mile up the drainage from the Middle Mine. This portal was also open, and some dirt had fallen in front of it. Facilities at this site include a pond

Photo 7. The Bromide Mine and associated highwall.

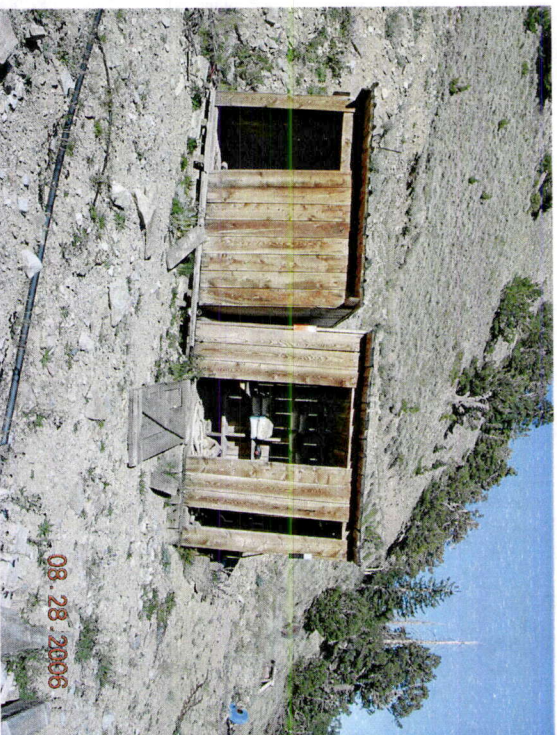
(Photo 6) and about five sheds (Photo 5). One of these sheds is apparently used as an explosives magazine, but we did not look to see if explosives were present.

Photo 8. Two of the buildings near the Bromide Mine.
